# *Analysis of Reliability and Seismic Appraisal of a Reinforced Concrete Hyperbolic Cooling Tower*

*Guangdong Jianke Architecture Design Institute Co., Ltd., Guangzhou, Guangdong, 510925, China*

**Keywords:** Hyperbolic cooling tower; Structural inspection; Finite element analysis; Reliability appraisal; Seismic appraisal

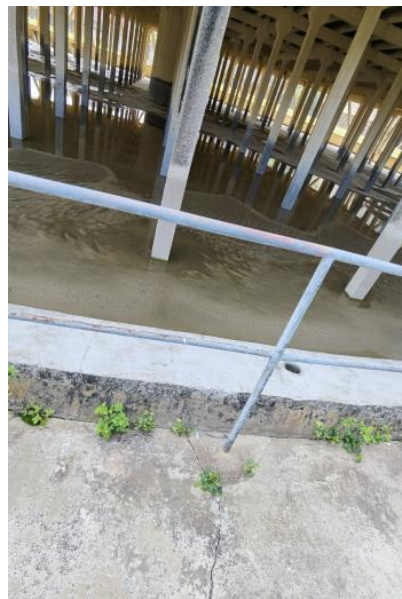
Figure 2: Outdoor Floor Crack 1

(1) Inspection of the outdoor floor damage defects: Near the polar coordinate system X-41, there is a crack on the outdoor floor that is perpendicular to the arc and extends outward, with a maximum crack width of about 3mm (as shown in Figure 2); Inspection of the relative displacement at the junction of the outdoor floor and the main structure: There is a separation between the outdoor floor and the outer side of the annular foundation, with a maximum crack width of 1.5mm (as shown in Figure 3).

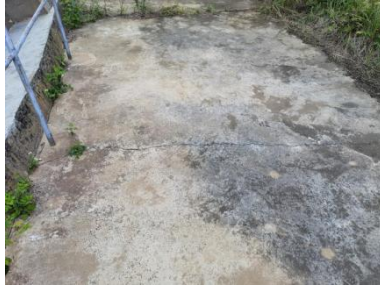
Figure 3: Outdoor Floor Crack 2

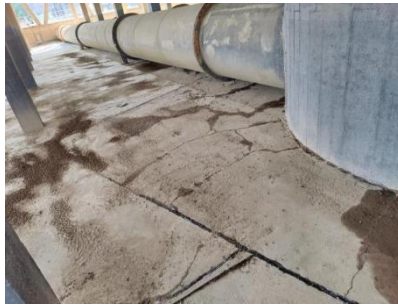
(2) Inspection of the indoor floor (pool bottom plate) damage defects: There are a large number of cracks on the indoor floor near the central vertical well (near the H axis) (as shown in Figure 4); no relative displacement phenomenon was found at the junction of the indoor floor and the main structure.

Figure 4: Indoor Floor (Pool Bottom Plate) Crack

Based on the on-site inspection, cracks were found in the outdoor floor and indoor floor (pool bottom) of the structure, but the usage condition of the upper load-bearing structure is normal. Therefore, the serviceability grade of the foundation is rated as B.

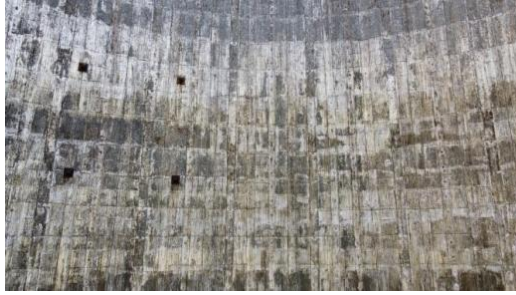
There is a large amount of scale on the inner wall concrete surface of the shell (as shown in Figure 6), and some of the concrete surface protective layers fall off and bulge, and no obvious stress cracks are found.

Figure 6: Scale on the Inner Wall Concrete Surface of the Shell

Based on the on-site inspection, the shell and diagonal columns all have exposed rebar, rebar rust, concrete surface falling off, etc. There is a large amount of scale on the inner tube wall of the shell, and some concrete surface protective layers are falling off and bulging, and no obvious stress cracks were found.

(2) It is recommended to repair the inner wall of the shell which has a lot of scale on the concrete surface, and some concrete surface protective layers have fallen off and bulged.
