# *Analysis of Reliability and Seismic Appraisal of a Reinforced Concrete Hyperbolic Cooling Tower*

*Guangdong Jianke Architecture Design Institute Co., Ltd., Guangzhou, Guangdong, 510925, China*

**Keywords:** Hyperbolic cooling tower; Structural inspection; Finite element analysis; Reliability appraisal; Seismic appraisal

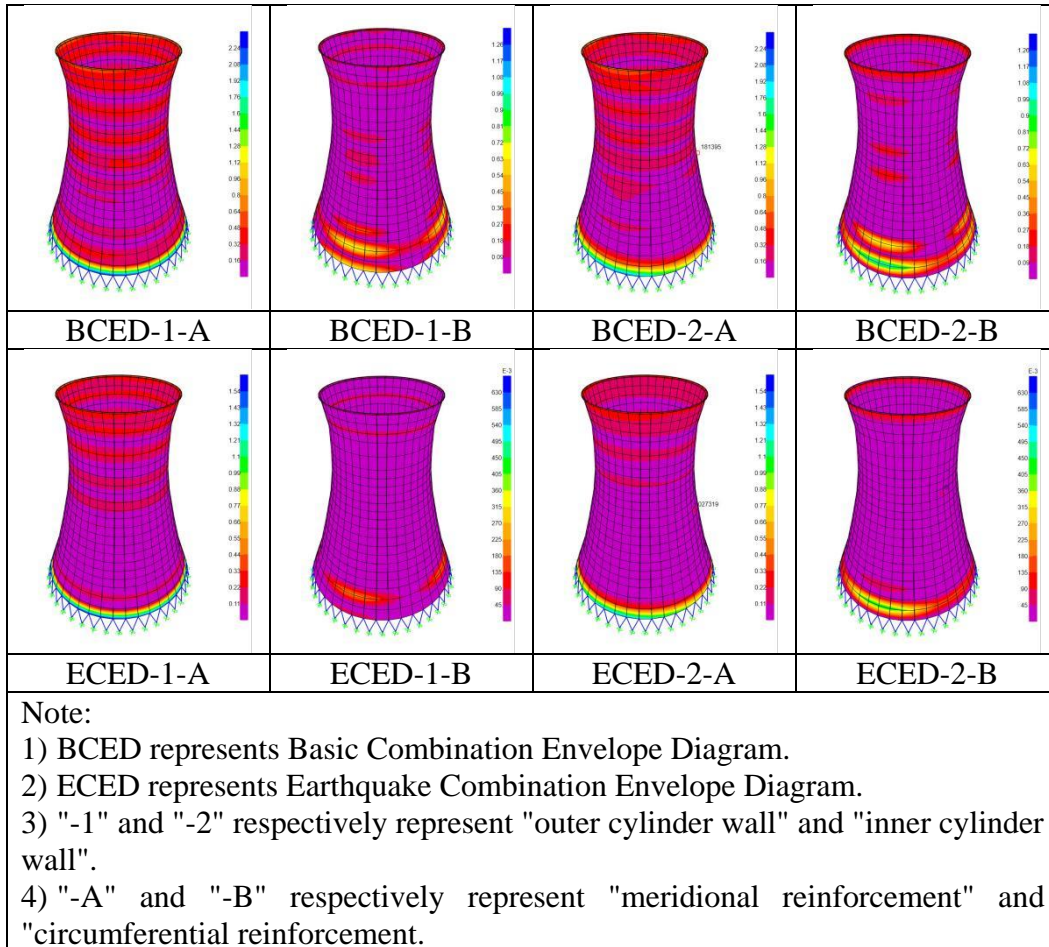
Table 1: Partial Reinforcement Envelope Diagram

Based on the existing drawing materials and on-site inspection, the project uses the finite element analysis software SAP2000 to model and analyze the shell and its diagonal columns. The analysis results show that the shell and its support structures meet the requirements of bearing capacity. Some of the calculation results are shown as table 1.
